The Application of Geophysical Methods in Identification of Subsurface Fractures in The Vicinity of a Poor Performance Percolation Tank

The village Karkatta is situated on Murud-Latur road. The total population of the village is 1500 souls. UNICEF has taken up this village under Multiple Water Users (MUS) project to educate the villagers to utilize their natural resources judiciously. The village was mapped geologically and covered social aspects. The survey revealed

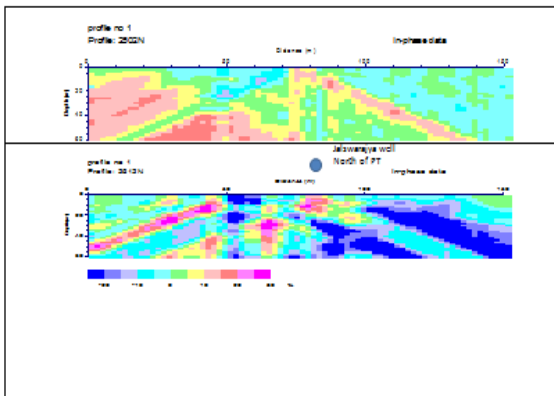
EM profile near Jalswarajya well (Northeast of PT)

(ii) Four em profiles are taken in east west direction covering the new Jalswarajya well. From VLF profiles shallow inclined profiles are observed from 70 m to 140 m length. Another inclined fracture is observed from 0 to 50 m length in all profiles.

2. The minute fractures around Jalswarjya well is not inter connected. (As shown in em profiles).

1. Fracture Sealing Cementation (FSC) is recommended due east of Percolation tank to arrest the subsurface fractures so as to retain water in percolation tank.
2. Bore Blast Technique (BBT) is recommended around Jalswarajya well to increase the effective diameter of the well.

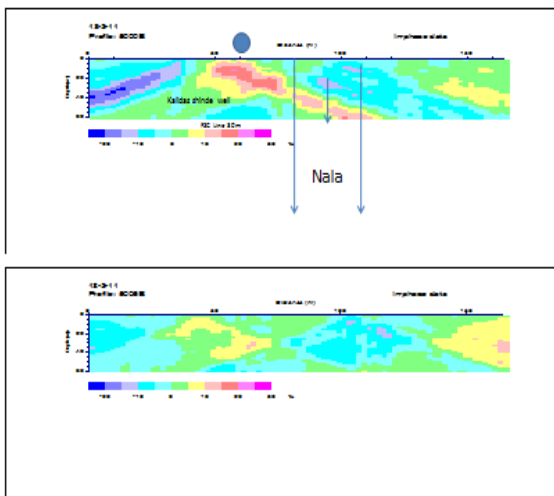
EM profile in N-S direction across nala, near PWS well Down stream of PWS well

(i) Geophysical resistivity and electromagnetic surveys conducted covering two dugwells. (Plate 1) There are four VLF Profiles taken in north-south direction along cart track near PWS well. A prominent fracture is observed from 50 to 80 m length, which covers the dugwell of Shri. Kalidas Shinde. The width of the fracture is 30 m. (Plate 2). North of nala is devoid of fracture, where the PWS well of Karkatta and PWS well of Borgaon kale are located.

1. The fracture observed on em profile shows that seepages are occurred southern side of nala connecting the Shri. Kalidas Shinde well. The dugwell of Shri. Kalidas Shinde located on vesicular basalt, which is acting as carrier through which percolation water leaking. The north of nala is covers hard massive basalt,
