Safety Audit Analyse – An Accident Study in Chemical Industry

a) THE STYRENE VAPORRELEASES ACCIDENT

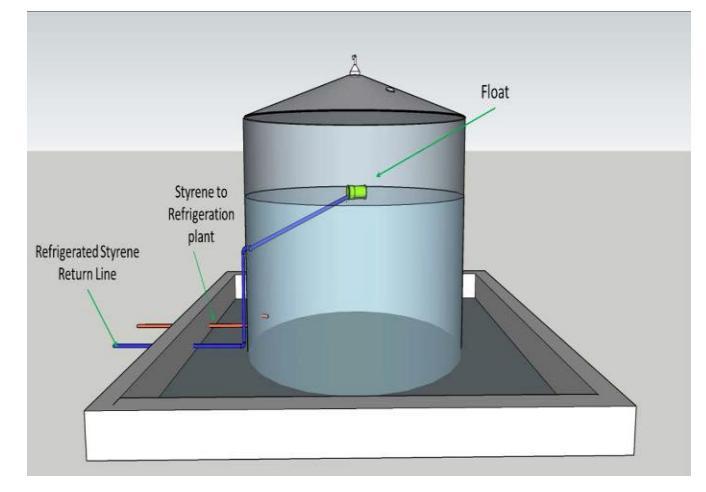
On specific query about the changes carried out, they have further informed that the modification had not been informed to PESO or any other concerned statutory organization to get it approved thinking that only a change in the piping only. This was a critically wrong assessment on the part of the company. Any modification of equipment or plant should be subjected to HAZOP and Risk Assessment Study. Originally, the tank was having a swing pipe arrangement to discharge the cooled Styrene from the recirculation and refrigeration unit, just below the liquid surface. Thus, the cooled liquid was delivered at the top of the tank and by its chemical property, it would slowly circulate to the bottom of the tank from where it would be pumped through the refrigeration unit. Thus, the contents of the tank were well mixed by the chemical properties, as the denser cold Styrene moves down towards the bottom by gravity and natural convection, such that the temperature would be less thermally stratified in the tank. As the float valve got stuck in the stalactites in the M6 Tank, as a result of which, the firm had to discard the piping connected to the float valve and bring in alternate piping of dip leg arrangement. The alternate piping provided for the cooled Styrene monomer liquid to be delivered at the bottom of the tank.

The floating arrangement in M6 tank

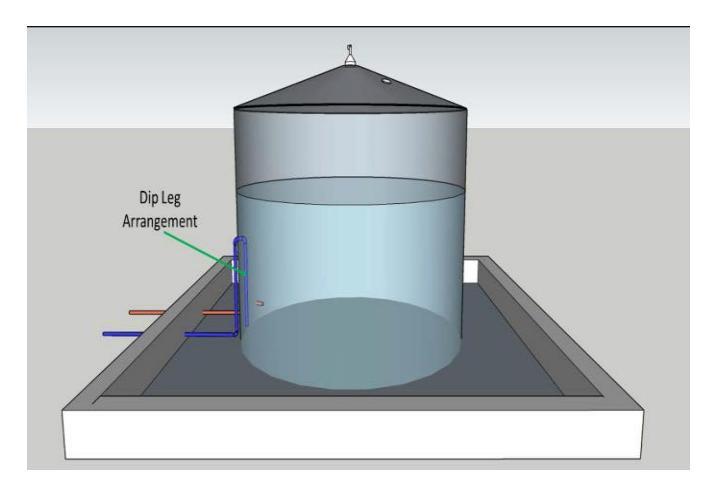
Dip Leg modification in M6 Tank

40°C to 20°C. But in practice, it was being used to cool the Styrene up to 17°C. This was also caused due to the change in the piping design in the M6 Tank. It may be seen that the float swing pipe arrangement was replaced with dip leg arrangement with release of cooled Styrene Monomer liquid at virtually at the bottom of the tank viz., 300 mm from the bottom. Similarly, the liquid Styrene monomer is taken into the refrigeration cooling system from the N13 port, located at nearly the bottom of the tank at 100 mm..it totally destroyed the natural chemical circulation (mixing) system. Moreover, it resulted in cooled liquid Styrene Monomer being pumped for further cooling in the refrigeration system. This is the cause why the temperatures at the bottom of the M6 Tank recorded low temperatures in the range of 17°C.

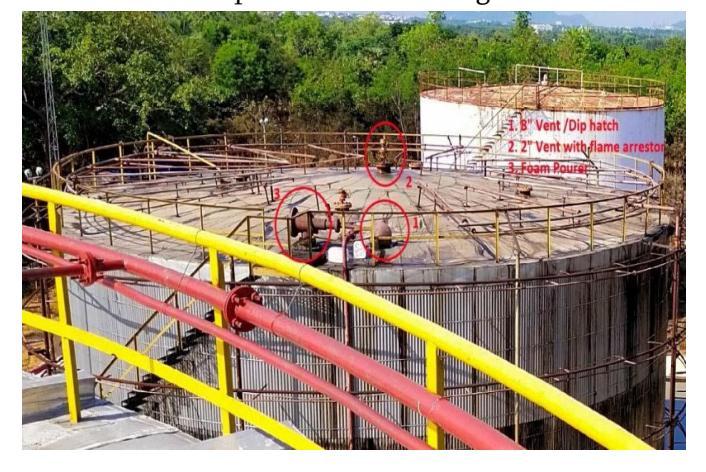
In the early hours of 7th May 2020, the Styrene storage M6 Tank with 1937 MT storage had started uncontrolled release of Styrene vapors from the top of the tank through the Flame arrestor / Vent (N6) and Dip hatch vent (N1), which spread beyond the factory boundary, affecting the neighboring areas & habitations.

As the vents of the tank are open to atmosphere, emissions of Styrene are prevalent. Unlike the modern designs, the tank neither has a flare system that burns the Styrene vapours forming carbon dioxide nor a cryogenic system to condense Styrene vapours that can be collected separately. The bulk storage tanks should be vented to a vapour collection and containment system that effectively eliminates discharges of Styrene monomer vapour to the atmosphere. The M6 Tank is not provided with any of the above safety systems.

Roof Top of M6 Tank Showing Vents
