Maintenance Strategy for Prevention and Protection of Industrial Component from Failure due to Hydrogen Embrittlement

Ramesh Yadava¹, Dr. Manish Vishwakarma²

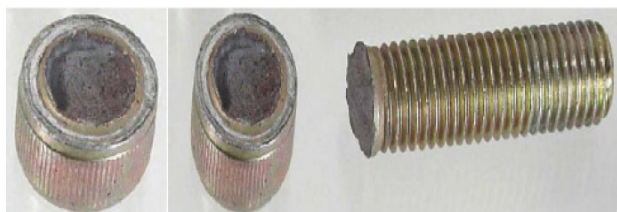
Figure 1 : Typical Fastener Failure by Hydrogen Embrittlement [8]

When high strength steel is tensile stressed, as is the case with a high strength fastener that is under tensile load from tightening, the stress causes atomic hydrogen within the steel to diffuse (move) to the location of greatest stress (e.g., at the first engaged thread or at the fillet radius under the head of a bolt). As increasingly higher concentrations of hydrogen collect at this location, steel that is normally ductile gradually becomes brittle. Eventually, the concentration of stress and hydrogen in one location causes a hydrogen induced (brittle) micro crack. The brittle micro crack continues to grow as hydrogen moves to follow the tip of the progressing crack, until the fastener is overloaded and finally ruptures. This hydrogen damage mechanism can cause the fastener.

In 2013, six months prior to opening, the East Span of the Oakland Bay Bridge failed during testing. Catastrophic failures occurred in shear bolts in the span, after only two weeks of service, with the failure attributed to embrittlement, possibly from the environment.

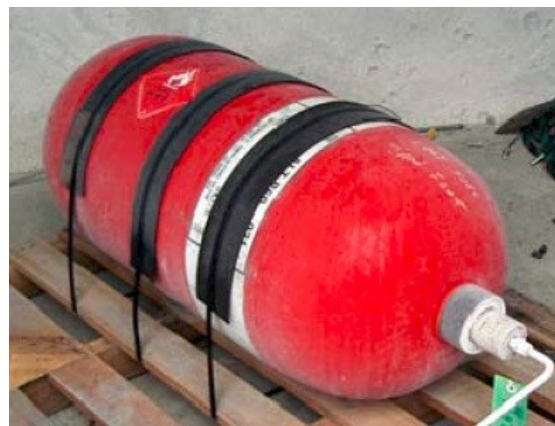
Figure 2 : High Pressure Hydrogen storage tank

Currently, austenitic stainless steel AISI 316 (SS 316) is the predominant material of construction for high pressure hydrogen components and tubing, and has recently been incorporated into the construction of high pressure hydrogen storage tank liners.

A first example is the failure of a storage tank for compressed hydrogen. The consequences of this can be ascertained from Fig. 1. This failure was caused by the growth of large fatigue cracks which was induced by hydrogen insurance. The total damage paid by insurance in this case was approximately US\$50 million.
