Investigations of Weldment Joints of Exhaust Pipes Using Non-Destructive Testing (NDT)

ABSTRACT

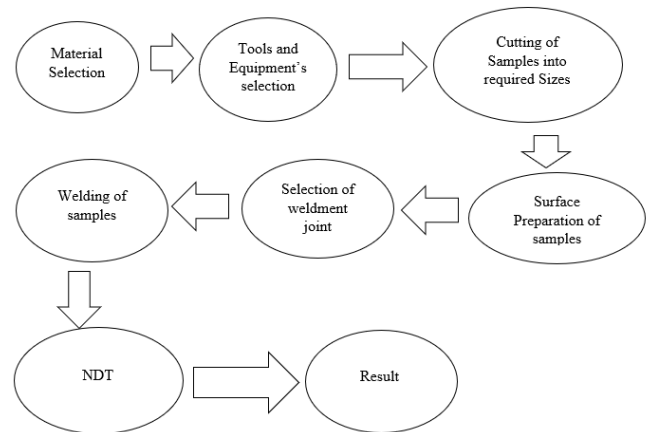
Figure 3 Sample preparation and testing flow chart

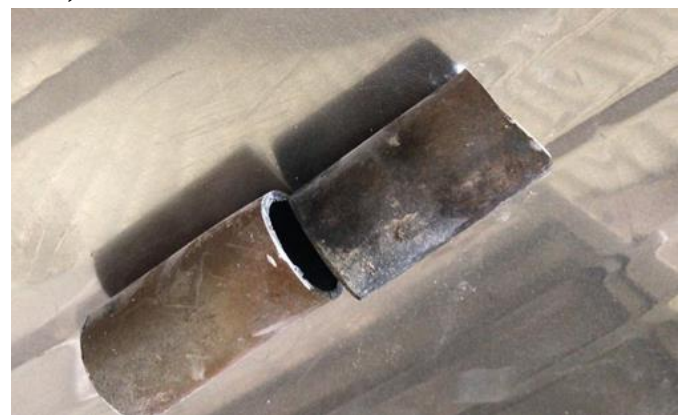
A total of nine (9) 75 x 50 x 10 mm material samples were selected after the cutting process for one type of welded joint. Out of the nine (9) samples selected, a total of six (6) welded sample was produced, and six (6) butt joint was selected in figure 4 show a cut sample butt joint.

Figure 4 : Sample of the selected Butt Joints

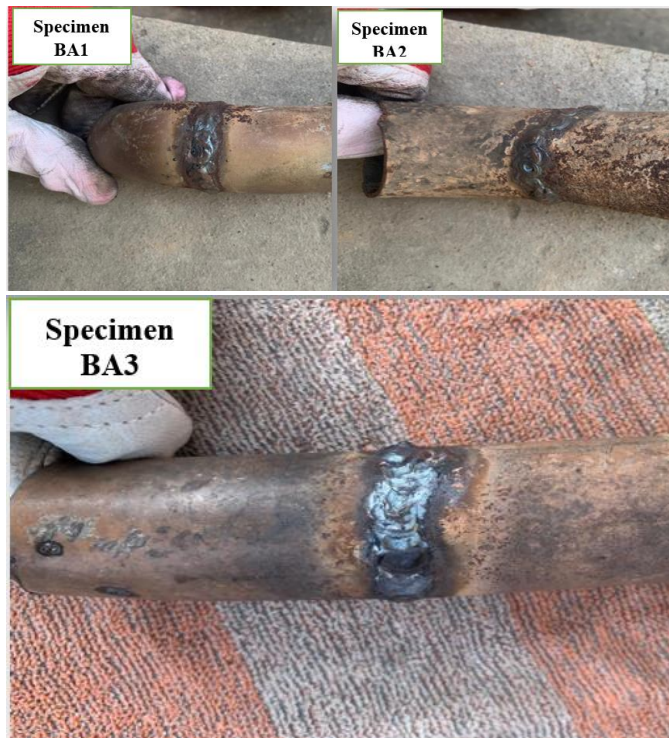
Specimens BA1, BA2 and BA3 in Table 3 and Figure 5 represent three samples of welded butt joints at workshop one. The butt joint has two sides, where one side was represented as the root and the front side. Specimen BA1, BA2 and BA3 had all defects which were surface porosity, excess weld metal, burn

through and spatter being rejected as per the code of acceptance. This result is a clear indication of improper welding operation as per standard.

Figure 5 Visual Inspection Result of Butt Joints of the Exhaust Pipes Welded at Workshop

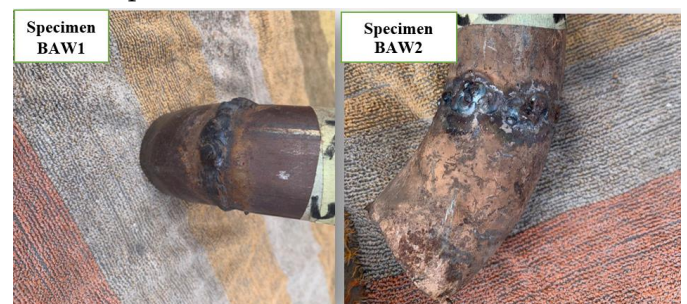
Specimen BAW1, BAW2 and BAW3 in Table 4 and Figure 6 represent three samples of welded butt joints at workshop two. The butt joint has two sides where one side was represented as the root and the front side. Specimen BAW1, BAW2 and BAW3 had all defects which were surface porosity, excess weld metal, burn-through and spatter being rejected as per the code of acceptance. This result is a clear indication of improper welding operation as per standard. The pointer in Figure 6 indicates a typical example of excess weld metal, therefore it was rejected after the visual inspection.

Figure 6: Visual Inspection Result of Butt Joints of the Exhaust Pipes Welded at Workshop 2

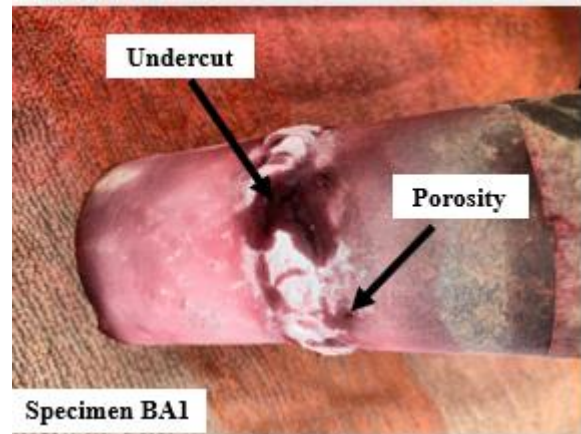
Figure 7: Dye penetrant inspection results for butt joint Workshop one.

Table 4 and Figure 7 represent dye penetrant testing results performed on a three-butt weldment specimen. Table 4, three specimens namely BA1, BA2 and BA3. Most recorded flaws in specimens BA1, BA2 and BA3 were rounded and linear indication, undercut, porosity and lack of fusion were rejected based on the ASME acceptance criteria used. In Figure 7 BA1, after the penetrant was applied to the surface of the joint it indicates a welding defect called an undercut. This welding imperfection is the groove formation at the weld toe, reducing the cross-sectional thickness of the base metal. Following a dye penetrant inspection of the first joint, it was discovered that the defects were caused by artisanal welders using excessive weld current. The welding speed was too fast. Incorrect angle, which directs more heat to free edges, incorrect filler metal, and Poor weld technique. This concludes that the weldment is not fit for the standard.

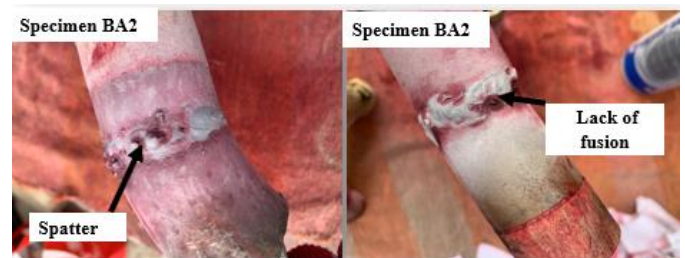
Figure 8 Spatter and Lack of fusion defect after the dye penetrant inspection

In Figure 8 the pointer indicates a welding defect called spatter and lack of fusion; which occurs when small particles from the weld attach themselves to the surrounding surface. It's an especially common occurrence in gas metal arc welding. No matter how hard you try, it can't be eliminated. However, there are a few ways you can keep it to a minimum. After a clear observation during the welding procedure, in Figure 9, the point indicates a defect called slag inclusion. Slag inclusion is a type of welding defect that is usually visible in the weld. Slag is a vitreous material produced by stick welding, flux-cored arc welding, and submerged arc welding. It happens when the flux, and the solid shielding material used in welding, are on the welded zone's surface.

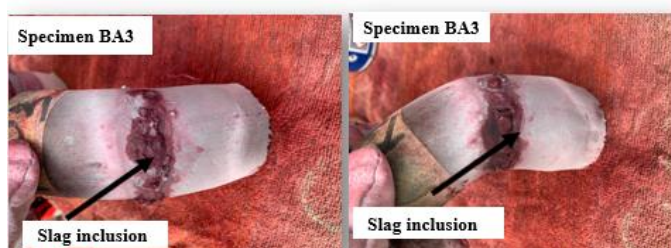
Figure 9 Slag inclusion defect after the dye penetrant inspection
