## Analysis of Various Losses in HVAC System

### ABSTRACT

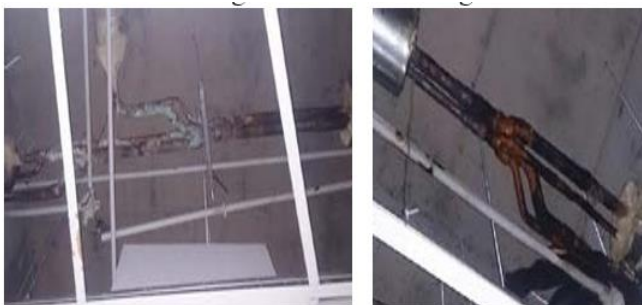
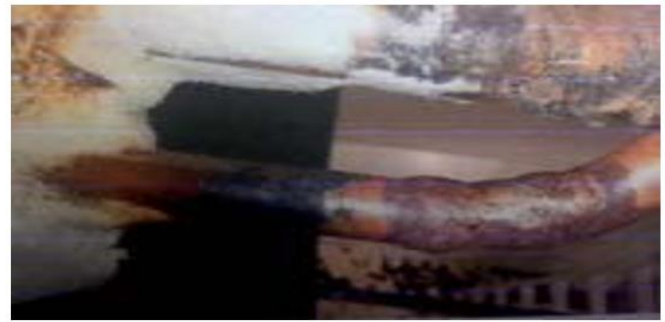
After a problem being reported in Help Desk system, Site Engineer staff with service contractor will investigate the problem on site. Among the troubles reported was indoor unit is not functioning which leading the room not being cool. A large amount of trouble occurs is due to leaking on pipe work which roots causes stemming from poor installation, poor workmanship and also poor maintenance practice. With dry nitrogen, brazing work, retighten, vacuum work, and renew refrigerant R-410A and also testing and commissioning.

**Figure 6 :** Improper installed pipe due to poor workmanship
