## Reclamation of Potholes by Utilisation of Plastic

### ABSTRACT

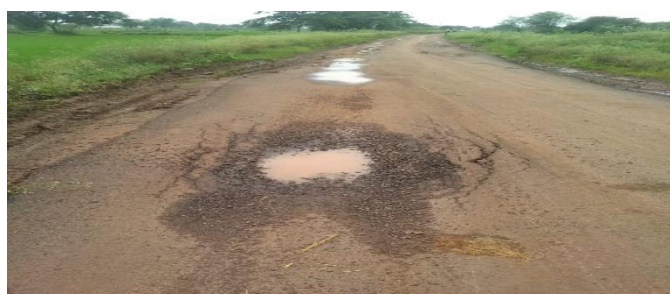
Only Two Potholes were found at Naya Raipur from Muktangam Garden to Mantralaya Road the potholes are shown in Figure 2.1 and dimensions of potholes are shown in Table 2.1

**Figure 2.1 : Identified potholes**

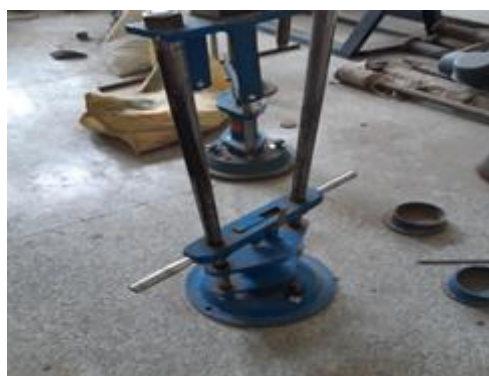
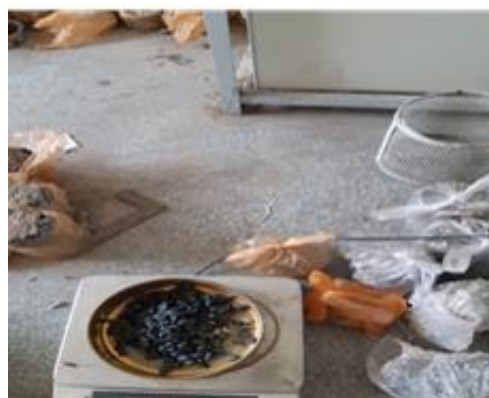
This test measures the resistance to sudden shock that is caused due to application of loads. This test is done on aggregate as per I.S. Code IS: 2386 Part 4. This test is used to determine toughness of aggregate. Impact Test is shown in Figure 2.2

**Figure 2.2 : Aggregate Impact Value Test**

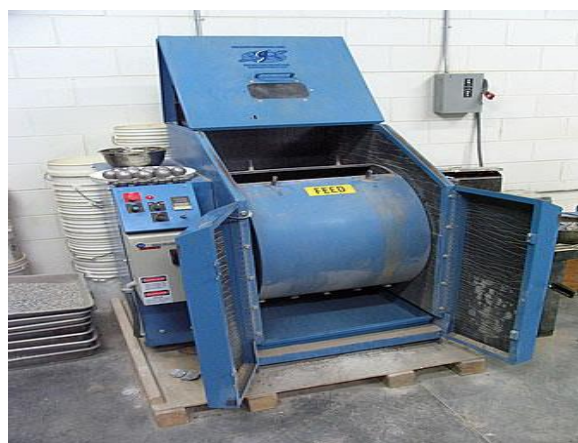
This test is used to check the quality of aggregate. This test is used to determine hardness of aggregate. Los Angeles Abrasion Test is shown in Figure 2.3.

**Figure 2.3 : Los Angeles Abrasion Test**

This test is done on aggregate as per I.S. Code IS: 2386 Part 4.

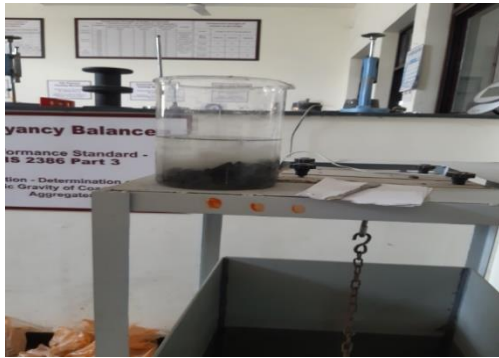
This test is done on aggregate as per I.S. Code IS: 2386 Part 3. This test is done to determine water content of aggregate. Moisture content Test is shown in Figure 2.4

Figure 2.4 : Moisture Content Test

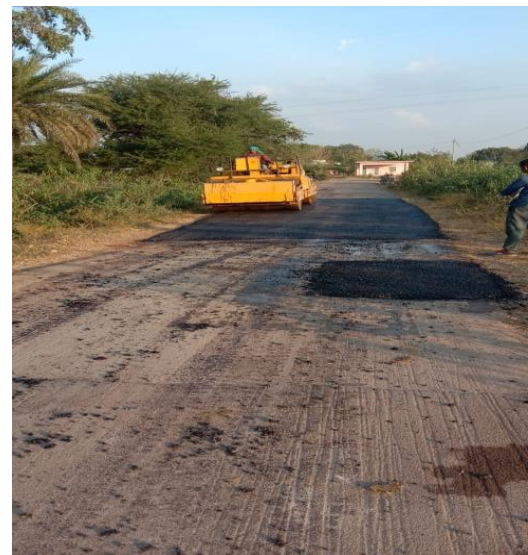
Fig 2.6 Repaired Potholes

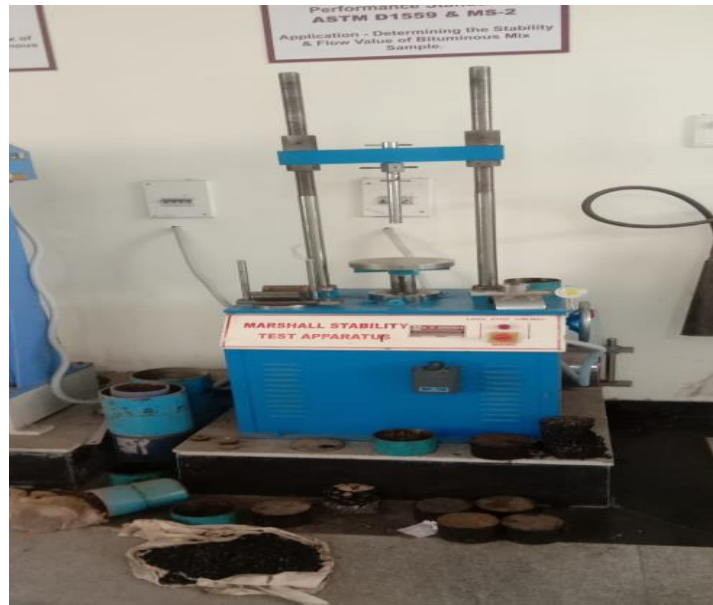
Marshall Test was done to check the stability of material .Marshall Test is done as per ASTM D6927 – 06. This test was done on 4%,4.5%,5%,5.5% and 6% of bitumen and 5%,6%,7%,8% and 9% of plastic. Marshall test apparatus is shown in fig 2.6

**Fig 3.1** Marshall Test Apparatus

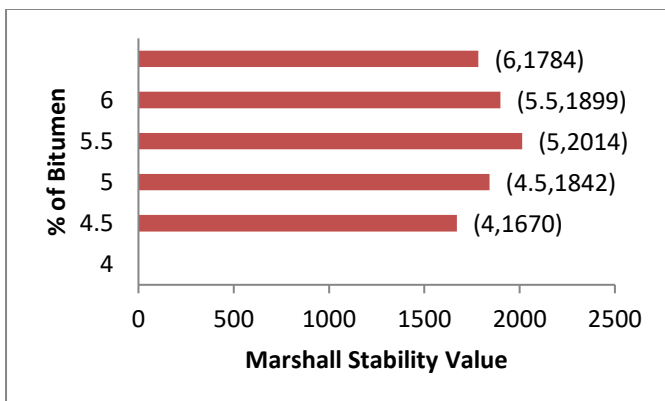
**Fig 3.2** - Different percentage of Bitumen and Marshall Stability Value

From figure 3. 2. it can be seen that stability value of 5% bitumen stability value is maximum as compared to 4% ,4.5%,5.5%and 6% .

Table 3.1 Shows that Marshall Stability value of different percentage of bitumen and from the table it can be seen that the stability value of 5% bitumen is maximum.

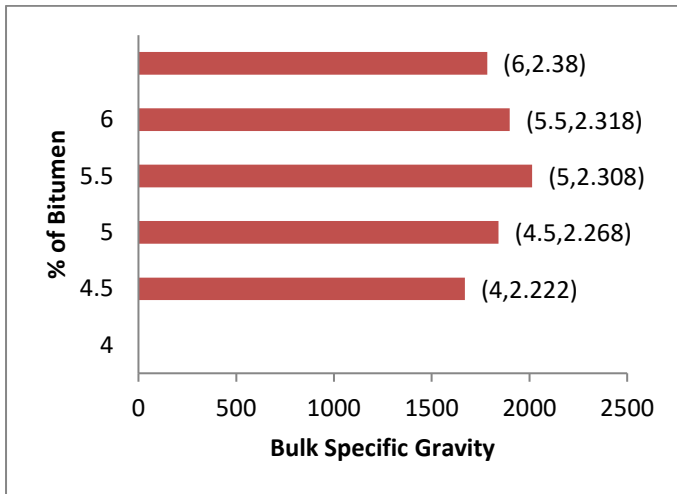
**Fig 3.3** Different percentage of Bitumen and Bulk specific gravity

The 3.3 figure shows that when 6% bitumen has maximum bulk specific gravity as compared to 4% ,4.5%,5.5%and 5%.

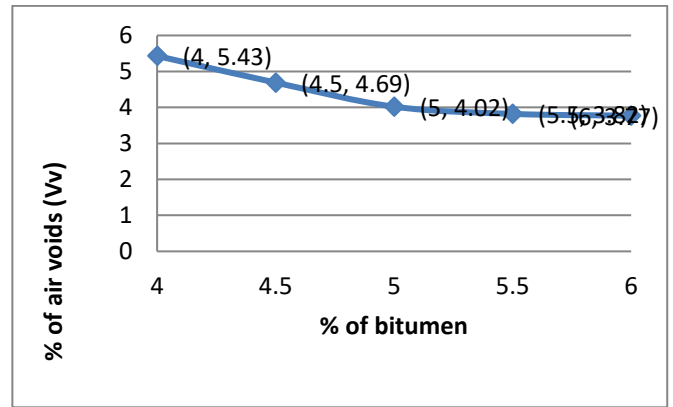
**Fig 3.4** - Different % of Bitumen and % of Air voids  
From figure 3.4 it can be seen that that 4% bitumen has maximum value as compared to 4.5%,5% ,5.5% and 6%

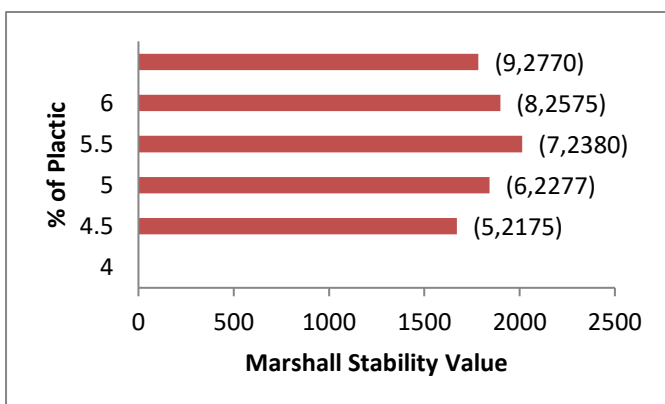
**Fig 3.5**-Different percentage of Waste Plastic vs. Marshall Stability Value

From figure 3.5 it can be seen that as the percentage of plastic is increased the stability value also increases. Hence 9% plastic has maximum stability value.
