Geographical Perspective of Geomorphological Hazards in Kohima District of Nagaland

Keywords : Geomorphological Hazards, Landslides, Monsoon Rainfall

Figure 1: Study area map viz., Kohima district of Nagaland

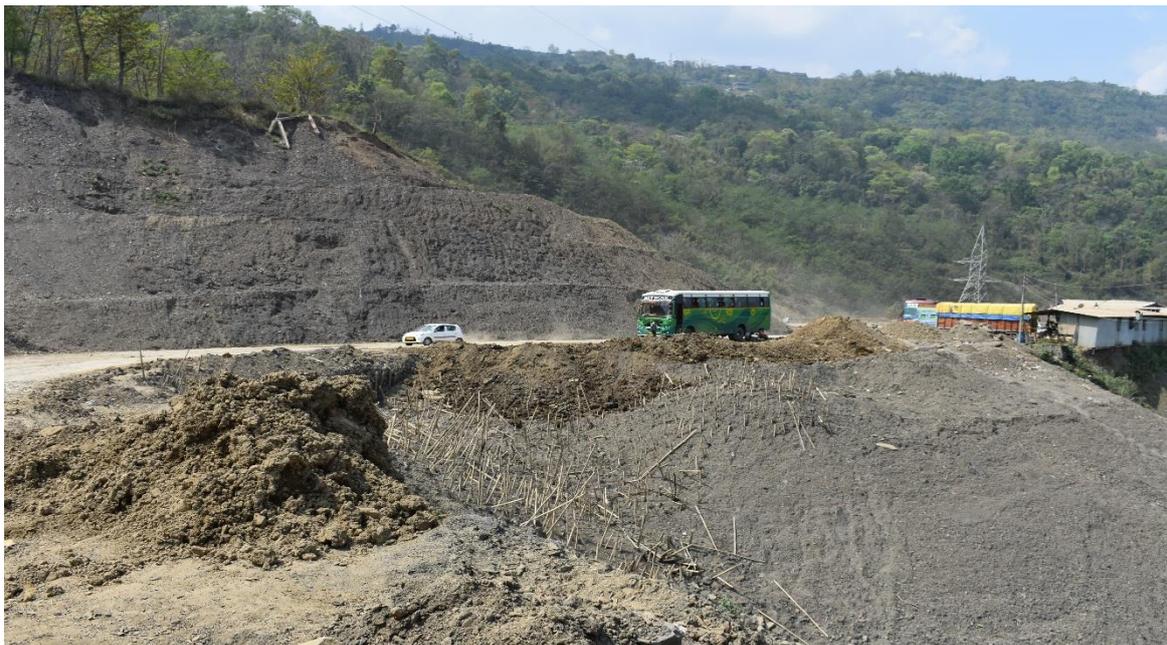
Figure 3: Dumping of materials along the NH-29 highway due to road construction.

Subsequently, the slide continued in 2019, also owing to anthropogenic activities such as earthwork due to road construction. Road construction is said to require the removal of 60000m³ of debris for a 1 km length of the road, which is very damaging for hilly terrain. Road sites

have erosion 10x more than agriculture, 200x more from grassland, and 2000x more from forest cover land. Dumping of road-cut material puts excessive pressure on land.

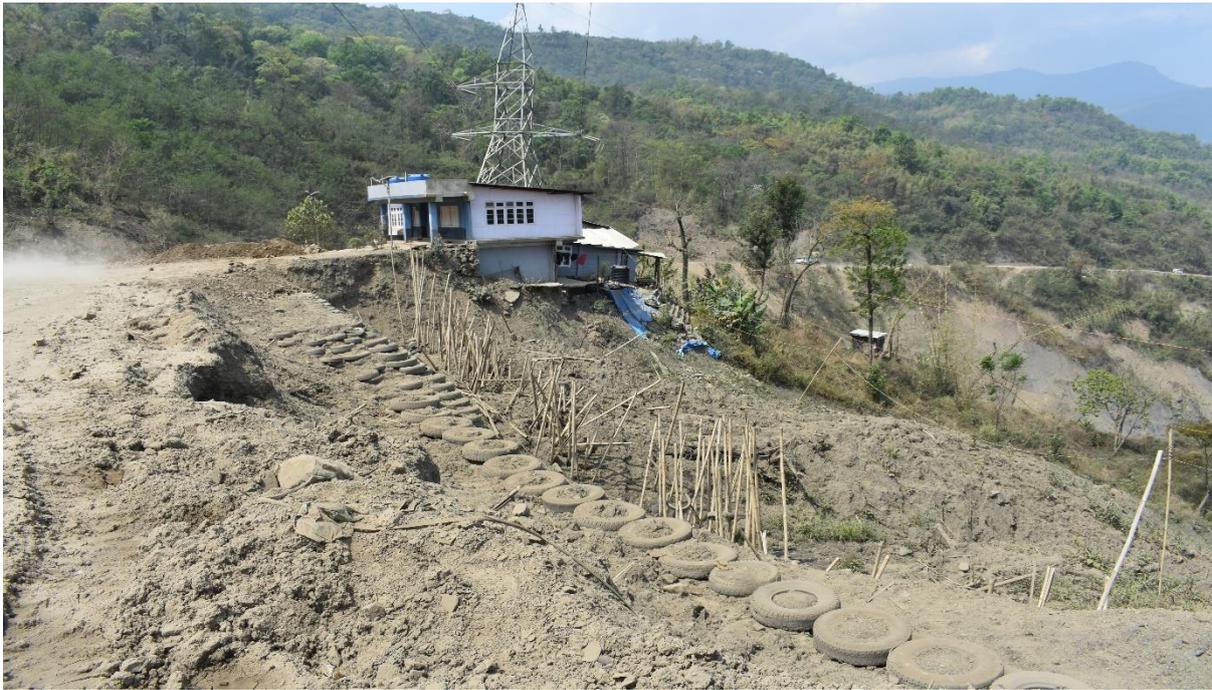
Figure 4: Indigenous treatment of landslide by bamboo hammering downslope of NH-29
