The Application of Geophysical Methods in Identification of Subsurface Fractures in The Vicinity of a Poor Performance Percolation Tank

The village Karkatta is situated on Murud-Latur road. The total population of the village is 1500 souls. UNICEF has taken up this village under Multiple Water Users (MUS) project to educate the villagers to utilize their natural resources judiciously. The village was mapped geologically and covered social aspects. The survey revealed

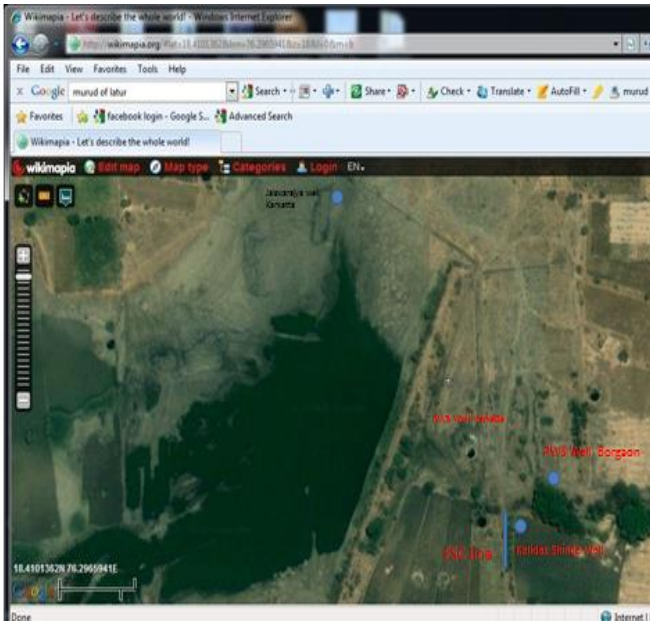
EM profile near Jalswarajya well (Northeast of PT)

2. The minute fractures around Jalswarjya well is not inter connected. (As shown in em profiles).

1. Fracture Sealing Cementation (FSC) is recommended due east of Percolation tank to arrest the subsurface fractures so as to retain water in percolation tank.
2. Bore Blast Technique (BBT) is recommended around Jalswarajya well to increase the effective diameter of the well.

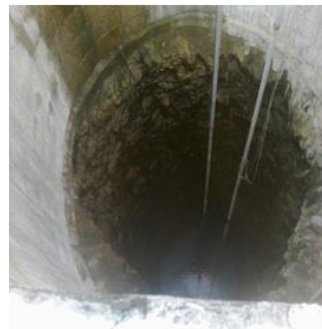
Dugwell in the land of Kalidas Shinde

1. The fracture observed on em profile shows that seepages are occurred southern side of nala connecting the Shri. Kalidas Shinde well. The dugwell of Shri. Kalidas Shinde located on vesicular basalt, which is acting as carrier through which percolation water leaking. The north of nala is covers hard massive basalt,
